ROOT-CAUSE ANALYSIS OF THE LACY COPPER PHENOMENON

* A. R. Almansa, T. Bravo, G. Ríos and R. Ramírez
ATLANTIC COPPER SLU (A Freeport McMoRan Company)
Avda. Francisco Montenegro s/n. Huelva, Spain 21001
(*Corresponding author: arodrigu15@fmi.com)

ABSTRACT

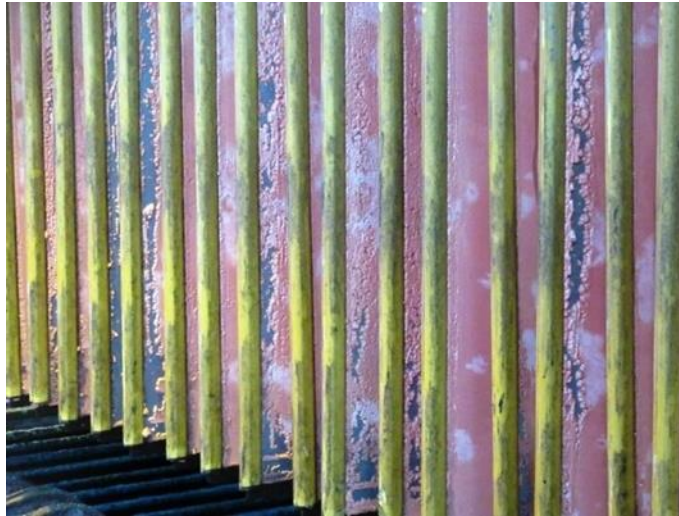
A lack of copper deposition in the lower part of the steel permanent cathodes was first reported in 2010. This phenomenon is known as "Lacy copper" because of the appearance of the copper deposit as it can be seen in Figure 1. The occurrence of this phenomena was relatively low and was assumed to be originated by an excessive anode scrapping. Nevertheless, in December 2015 Lacy Copper was observed in a significant amount of copper cathodes giving rise to the following issues:

Figure 1. Lacy copper examples

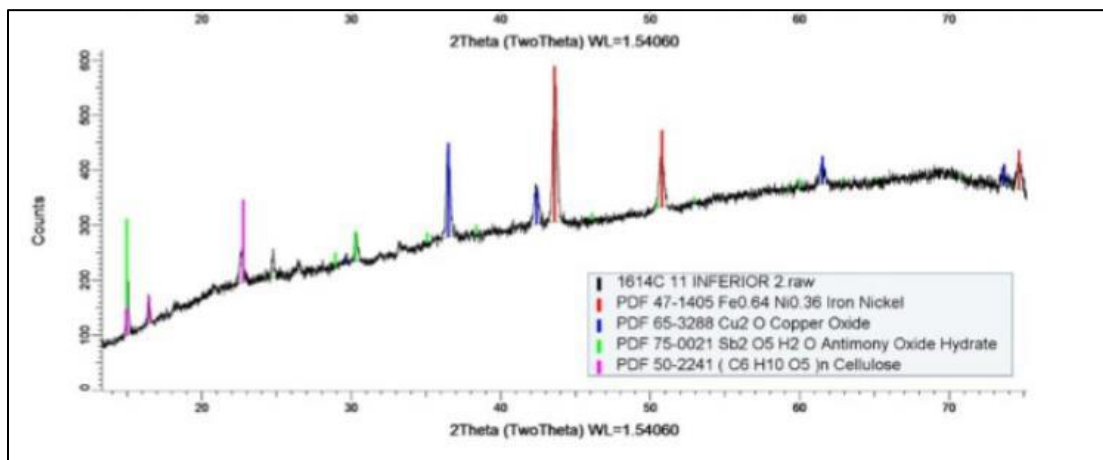
The main difference between the passive and the active areas was the presence of C, O, Cu, S, As, and Sb. As shown in Figure 5, the XRD analysis of the passive area suggests that Sb oxides may be found on the steel surface. This finding would be consistent with Wesstrom (2014) in which the effect of Sb oxides is described as an “oxide layer” that decreases the number of nucleation sites.

Figure 5. XRD analysis of a steel plate “passive” area

- Chemical analysis of the passive steel areas using SEM, EDS and XRD showed that Sb oxides contaminated these areas.
- Lishinsing the plates may remove that “oxide layer” but plates have to be relinished every six months. It is important to minimize the frequency and severity of linishing as this process can have adverse effect on plate life

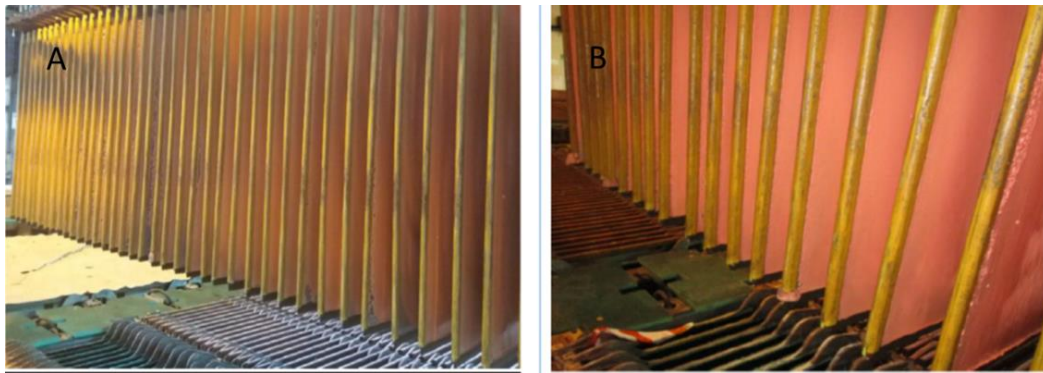
As it can be seen in Figure 11, the positive effect of working with longer anodes is significant as the occurrence of lacy copper is reduced in the first anode cycle from 65 % to 23 % in the third crop. This positive effect is also depicted in the pictures shown in Figure 12.

Figure 12. Overlap tests with 20 mm in Cell 1. A: cathodes before the test; B cathodes during the test
