# The link between operational practice and maximising the life of stainless steel electrodes in electrowinning and electrorefining applications

1. J. Weston

2. W. Webb

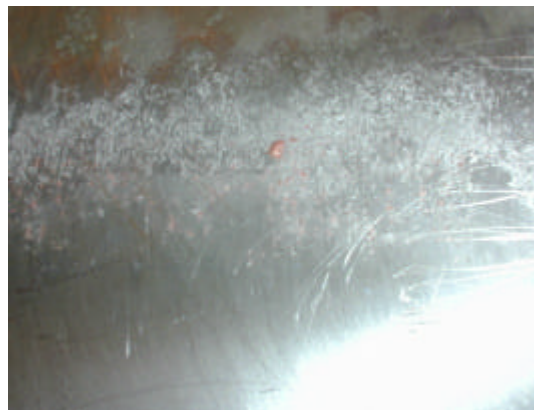
Figure 3: Surface corrosion of the cathode mother plate

The superior corrosion resistance of stainless steel is a result of the formation of a thin passive layer on the surface of the cathode plate. This passive layer mainly comprises of chromium oxide. If this layer is damaged and unable to rebuild itself, corrosion will occur in the unprotected areas (Hayes, 4). Great effort is then required to remove copper from corroded blades often resulting in damage to the cathode plate. Following copper removal, cathode plates are re-straightened and buffed to restore a useable surface. Figure 3 illustrates surface corrosion of the stainless steel blade.

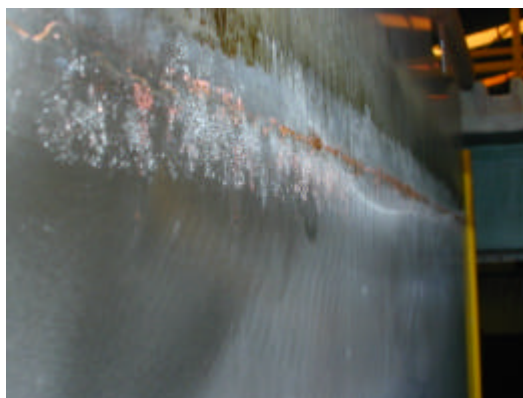
Figure 4: Solution line corrosion

Solution line corrosion is often characterised by pits above and around the solution line (illustrated in figure 4). Pitting may be due to chlorides and organic transferred from the SX plant. It may also be due to incorrect addition of chlorides for reagent purposes, further exaggerated by the presence of organic residue in the electrolyte.

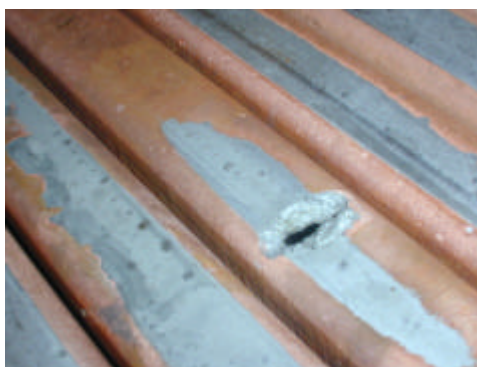
Figure 5      Damage caused to hanger bar from incorrect use of shorting frame

Uniform current distribution is critical during the operation of a shorting frame. Significant damage can result from uneven current distribution resulting in elevated temperatures and melting of the bar at the point of contact. Subsequently, penetration of the copper coating will accelerate the corrosion and this is illustrated in figure 5. Extreme temperatures may also soften and weaken the braze of the solid copper hanger bar systems, making them susceptible to corrosion attack at the joint.
